DEFENCE RESEARCH ESTABLISHMENT
CENTRE DE RECHERCHES POUR LA DÉFENSE
VALCARTIER, QUÉBEC

DREV - TR - 1999 - 137

CHARACTERIZATION OF POTENTIALLY EXPLOSIVES-CONTAMINATED SITES AT CFB GAGETOWN, 14 WING GREENWOOD AND CFAD BEDFORD

December/décembre 1999

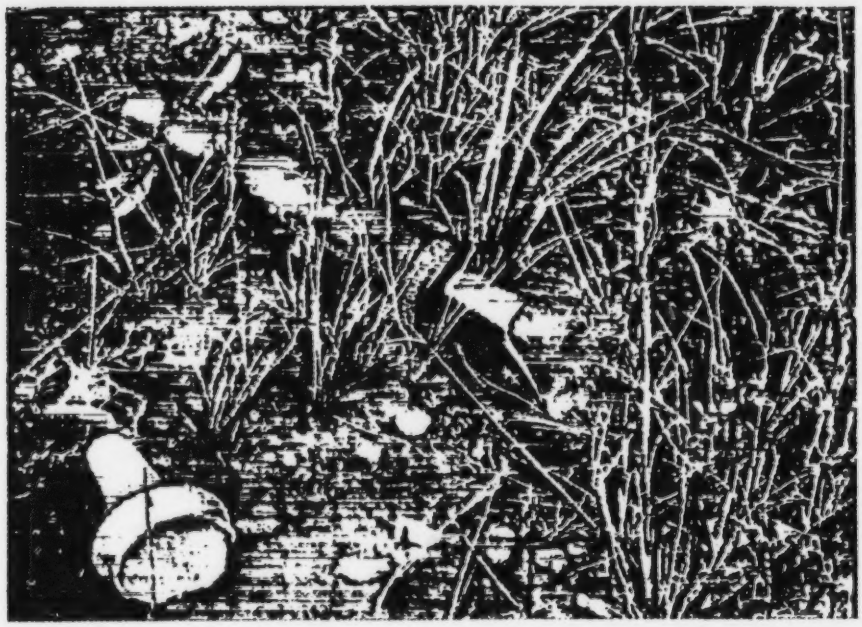
According to our past studies (Ref. 10), for the source of contamination of the Wellington Antitank Firing Range the main contamination source suspected for antitank ranges is the M72 ammunition. By having talked to many CF military personnel and by having seen many antitank ranges, we noticed that the M72 antitank ammunition has a very high dud rate. It has been demonstrated at WATC Wainwright, Alberta, Canada that this ammunition can reach more than 50% "dud producing" rate when fired under the best conditions. So, many duds can break when hitting the target or rocks and the explosive melt-cast formulation might be exposed to the environment. A picture of a M72 at WATC Wainright broken on the ground leaching explosive is shown in Fig. 1. No HMX contamination was found in the sample WX located between Targets W1 and W2, proving that there is less contamination found away from targets.

FIGURE 1 – Duds of M72 leaching octol in the environment

In general, for all sites that might be in contact with explosives, care should be taken in collecting duds or post-combustion residues after each exercise or operation, thus

minimizing the spread of energetic materials in the environment and contamination. If these solutions are not feasible, then a level one clearance should be conducted more frequently on each site. Since the toxicity associated with explosives have been demonstrated in the past (Ref. 6), contaminated soil should be remediated where there is a possible exposure with personnel. Now, new remediation technology is available and has been demonstrated at our research facilities at CFB Valcartier (Ref. 17). At the present time, research is dedicated to developing a way to decontaminate in-situ, which would be the most appropriate way of decontamination for DND.

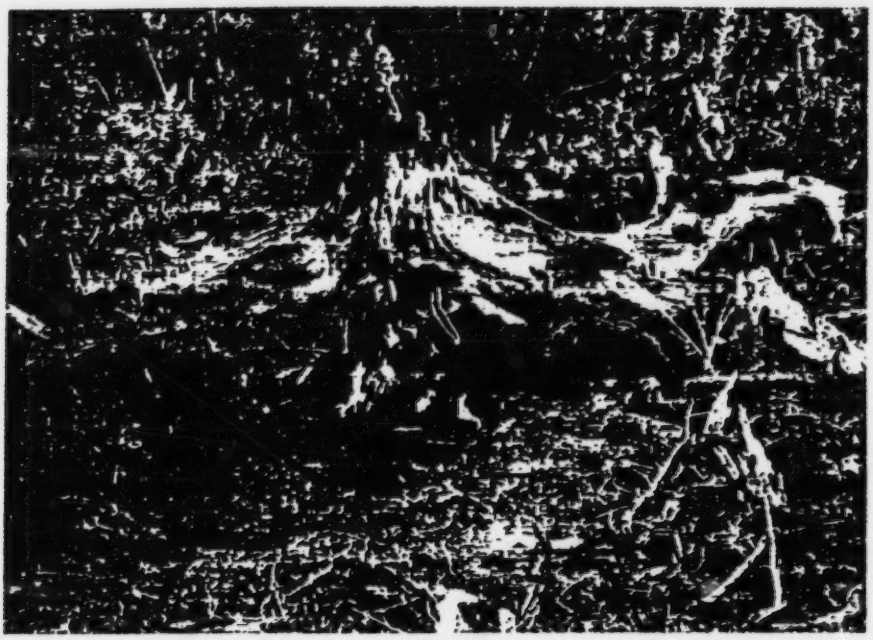
The explosive contamination found on the surface at those sites is low and negligible, except for the Wellington ATR where we found a high level of HMX contamination on the surface. Thus, we can confirm that the contamination on many ATRs in Canada is due to the M72 weapons system, which has a high dud rate and produces many broken casings that expose the Octol on the ranges, this leads soil and groundwater contamination by HMX and TNT. We would recommend that DND take action in order to minimize this unfortunate impact in the future by causing in the same no inconvenient on training or operations taking place on site. One possible solution that will need to be investigated is the correction of the high dud rate problem of the M72 munitions. On site, we have seen M72 ammunition hit the target directly without having detonated (as shown in Fig. 2).

FIGURE 2 – Unexploded M72 in a stump

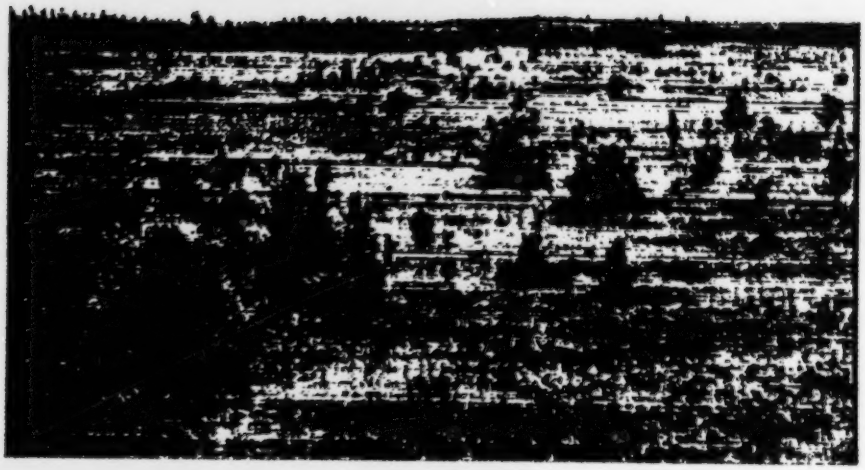
FIGURE 3- Pictures of the Wellington Antitank Range

The laboratory results obtained during the sampling of the Wellington Antitank Firing Range are reported in Table I. The eleven samples collected show high levels of HMX, except for WX, a sample taken between Targets 1 and 2 near a stump shown in Figs. 2 and 6. The concentrations are ranging from 66 to 1315 mg/kg. One sample (W1D) was co-contaminated by RDX, which is present as a production impurity in HMX, but to a much smaller extent. The concentration detected for the W1D sample was 0.94 mg/kg of RDX. TNT contamination was detected in most samples, except for the samples W1A, W1C, WX, W3B and W3C. The TNT concentrations did not show a correlation with the HMX concentration found in the ratio that we could have expected (30:70, TNT:HMX), based on the melt-cast octol formulation (Ref. 15). The ratio observed between the HMX and TNT concentrations were much lower than expected, probably due to a rapid leaching of more soluble TNT in the soils. This sampling demonstrate that the Wellington Antitank Firing Range is contaminated mainly by HMX at high levels.

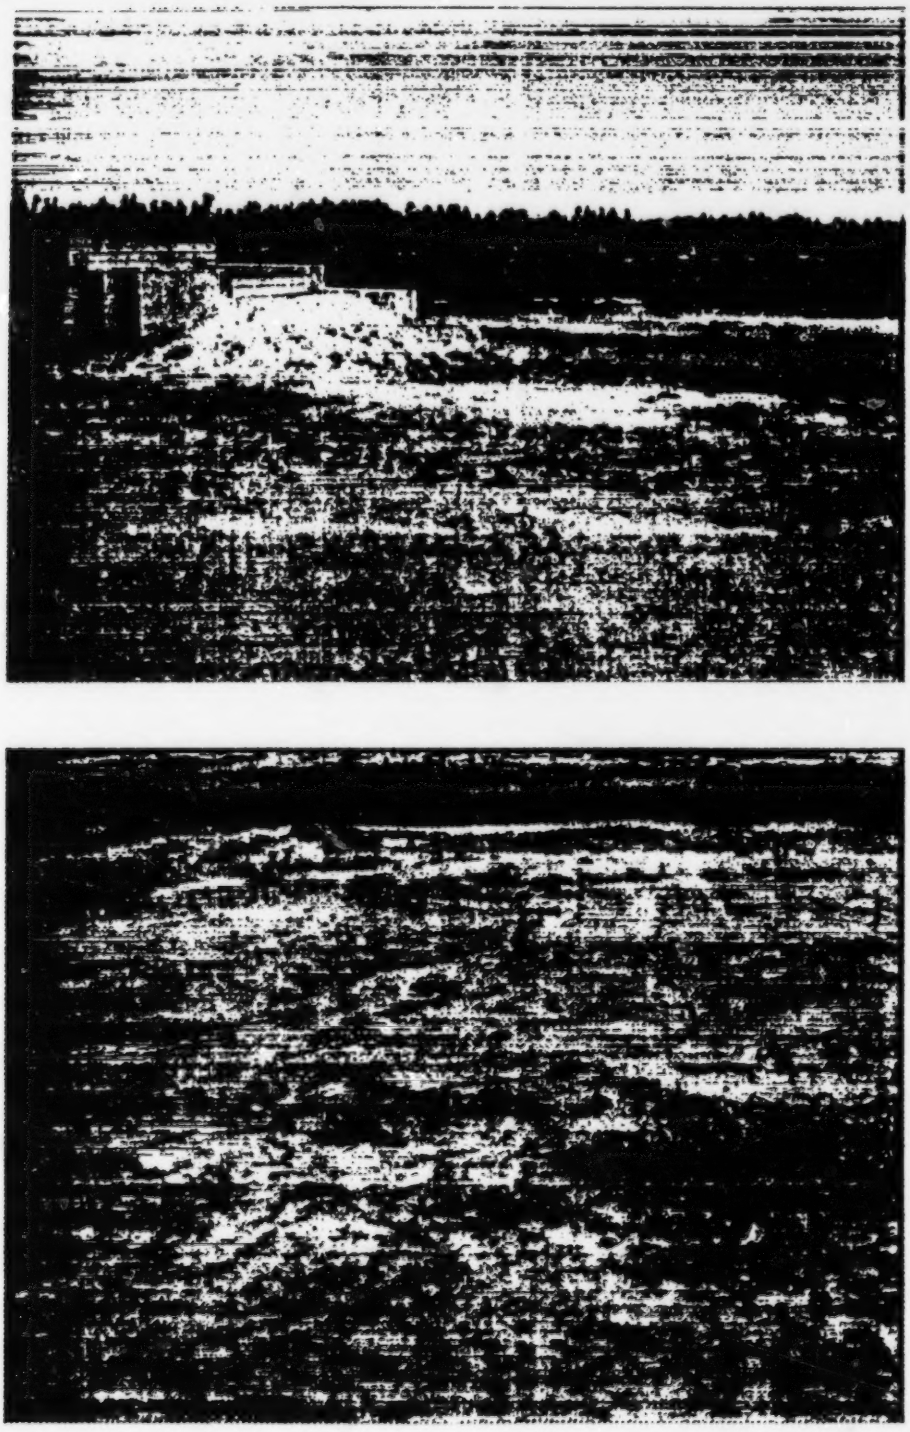
FIGURE 4 – Pictures of Castle Grenade Range, CFB Gagetown

The Castle Grenade Range shows a presence of RDX at low concentration, with the highest result at 47 mg/kg as reported in Table II. As for the Wellington Antitank Firing Range, the colorimetric field screening method was used. Only the samples C1, C2, and

For the source of contamination of the Castle Grenade Range, the low contamination of RDX is coming from the accumulation through the years of post-detonation residues of grenades and C-4. The M-67 grenade used on this site contains Compound B, made of 60% RDX and 40% TNT. C-4 is used also to detonate unexploded grenades on site; it contains RDX at 90%. At 14 Wing Greenwood, no information is available about the potential source of contamination. Finally, at CFAD Bedford there is no source of contamination since no significant contamination was found.

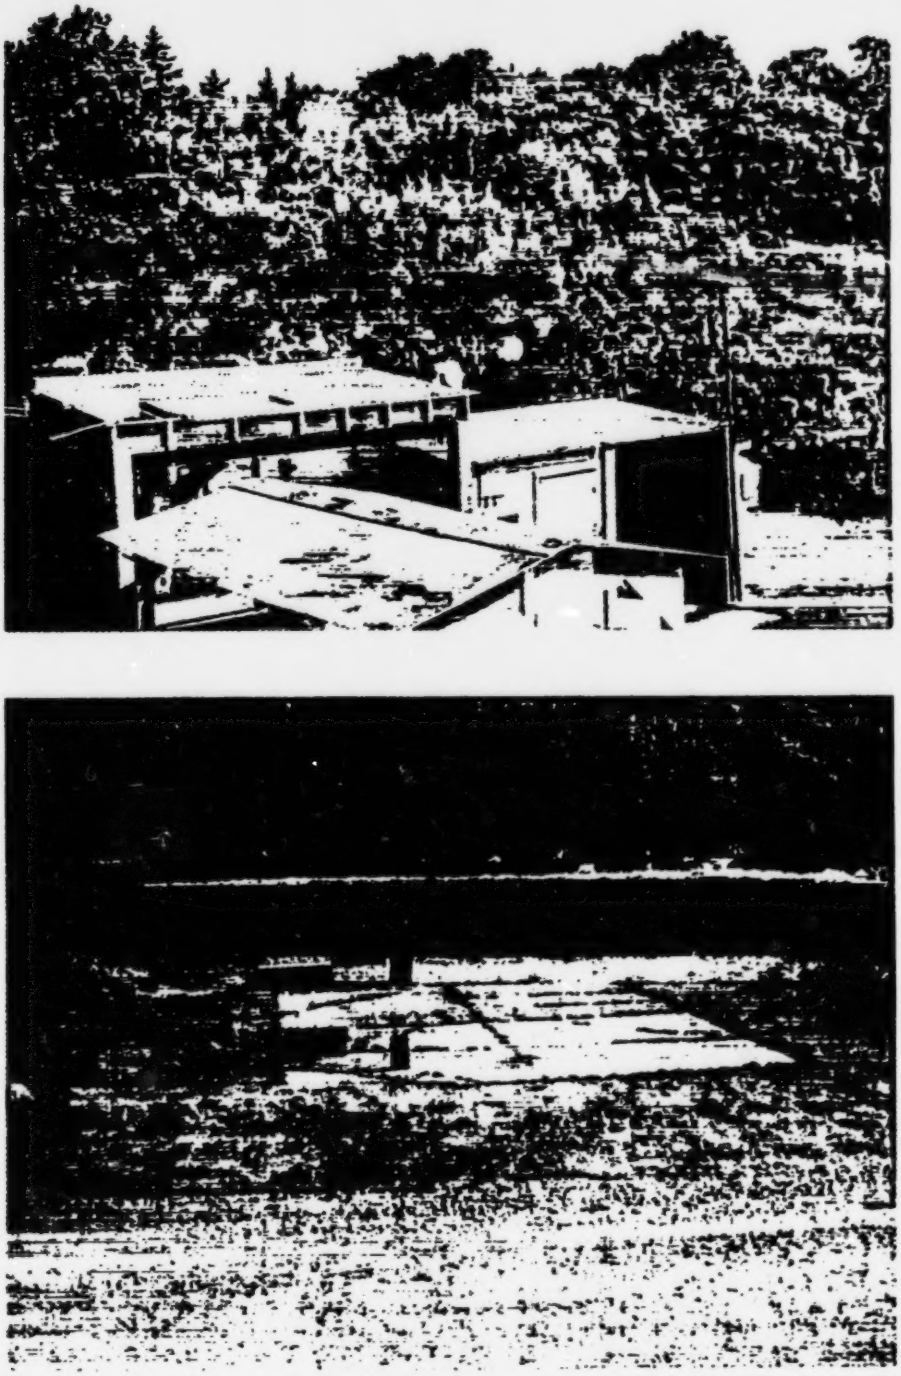
FIGURE 5 – Pictures of the CFAD Bedford site

The site sampled at CFAD Bedford showed a non-presence of RDX, TNT and HMX. The laboratory results showed non-contamination of explosive in our samples, as reported in Table V. As for the 14 Wing Greenwood site, enzyme immunoassay field screening method was used on site. The results obtained are reported in Table V. The field screening method indicated a potentially RDX contamination of 0.8 mg/kg at B5, which does not correlate with the results found by the laboratory method. A possible error at the Greenwood site can be pointed out, the false positive rate of the EIA field screening method being 4%, as suggested by the supplier (Ref. 14), the B5 result can be attributed to a false positive result. Therefore, we can conclude that there was no detectable RDX, TNT or HMX contamination in samples from CFAD Bedford.
